**Field Service Spares Replacement Procedure – EL & CL Motor Kit,
XX04 & XX06, EL Motor Kit, 6003A/6004**

Field Service Procedure – Replacement EL & CL Motor Kit, XX04 & XX06, EL Motor Kit, 6003A/6004

Troubleshooting document for diagnosing a fault with and replacing the elevation or cross level motor on the XX04 and XX06 series antennas, or the elevation motor on the 6003A/6004 antennas.

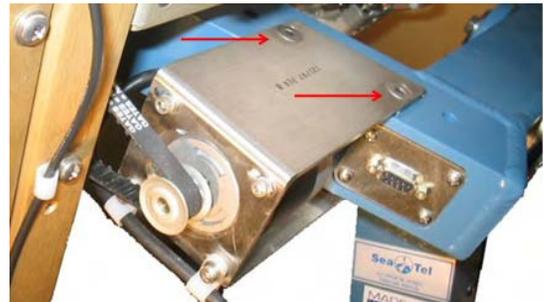
2. Using a 5/32" Allen wrench, remove the four Allen head screws attaching elevation motor bracket to CL beam and remove motor assembly.

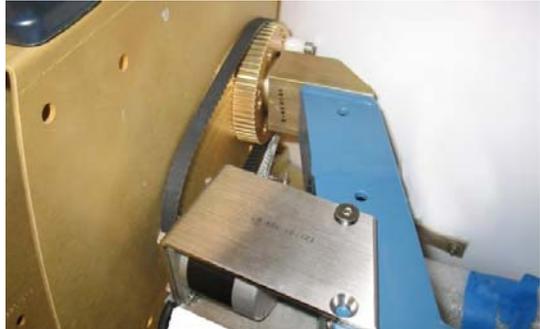
<p>6. Re-install the bracket onto the CL beam using two of the Allen head screws, do not fully tighten. Place the belt around the elevation drive sprocket and then elevation motor pulley.</p> <p>7. Install the other two Allen head screws and secure the motor bracket onto CL Beam using Loctite 242 on all four screws.</p> <p>8. Increase the belt tension until the belt can only be easily twisted just $\frac{1}{4}$ turn with your fingers.</p>

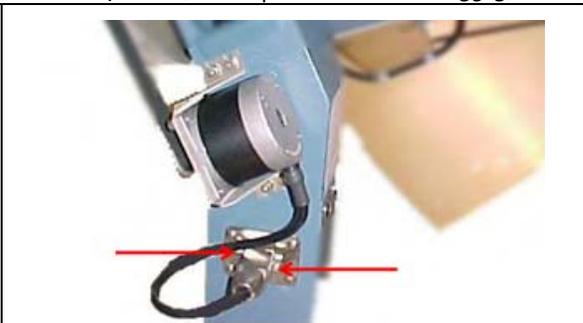
1. Using a 2mm flat blade screwdriver, loosen two retaining screws on the CL motor harness and remove it from the AZ post.

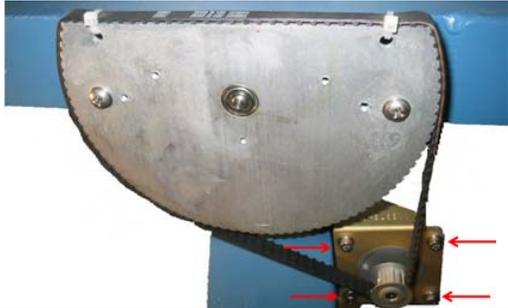
<p>2. Using a 9/64" Allen wrench, remove the four Allen head screws securing the CL motor to its bracket and remove it.</p>

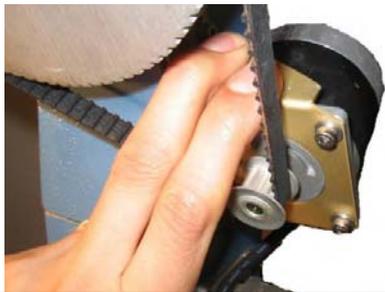
<p>6. Install the belt around the CL motor pulley and tension it by pulling the motor bracket down towards the antenna base and tighten the four screws.</p> <p>7. Increase the belt tension until the belt can only be easily twisted just 1/4 turn with your fingers.</p>

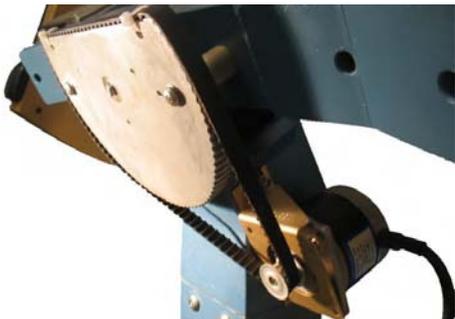
<p>8. Rotate the CL beam from the CCW stop to the CW stop (Left to right) and verify the CL belt does not rub against the AZ post and runs in line with both sprockets.</p> <p>*Note: Failure of this step is normally due to incorrect sprocket placement on the CL motor shaft.</p>
